EXPEDIENTE: 036/2025

# INFORME PRELIMINAR

INCIDENTE GRAVE  
SCF-NP

MATRÍCULA: YV3465

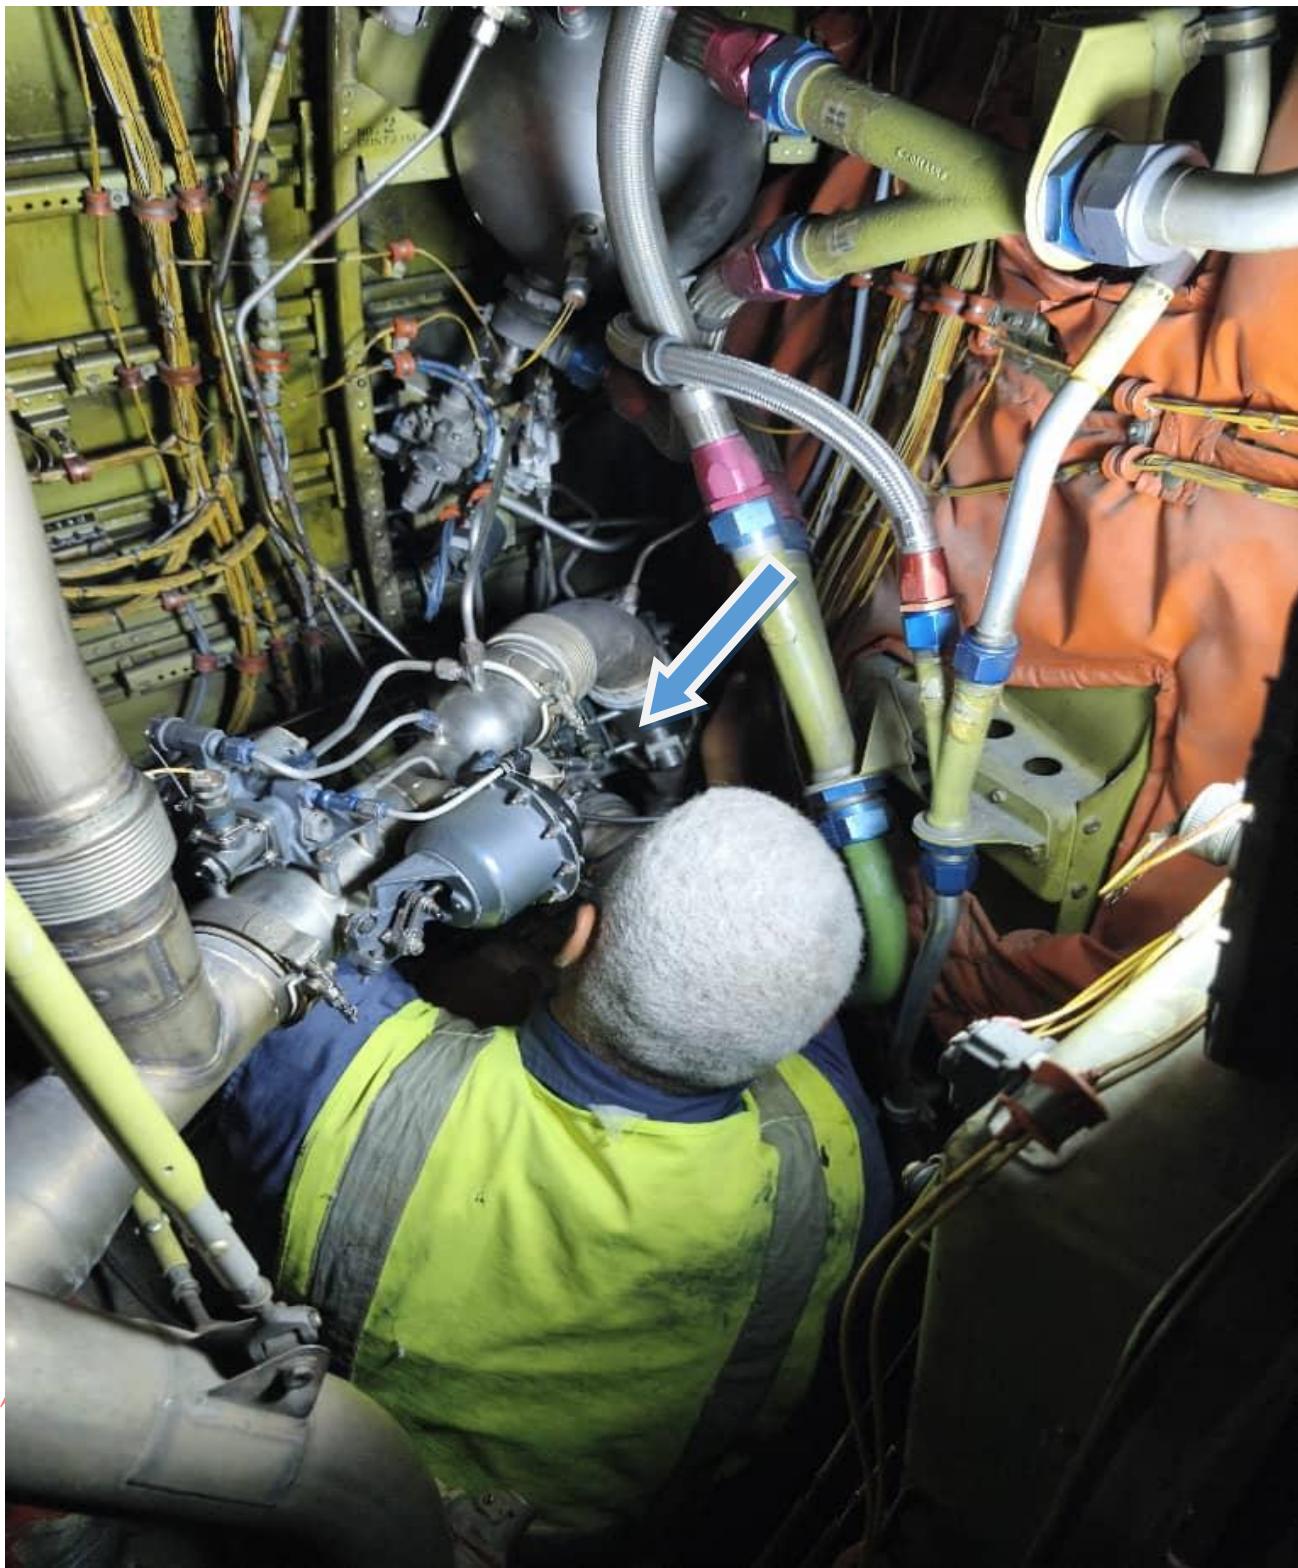
**Figura 4: Reemplazo de la Pressure Regulating Shutoff Valve YV3465.**  
**Fuente:** Investigador Encargado **Año:** 2025

Se requiere el cambio de las Pressure Regulating Shutoff Valve izquierda y derecha de acuerdo a lo indicado en el manual de mantenimiento.

- Se procedió con el cambio de la Pressure Regulating Shutoff Valve lado izquierdo de acuerdo al AMM: 21:31:01.
- Se procedió con el cambio de la Pressure Regulating Shutoff Valve lado derecho de acuerdo al AMM: 21:31:01.
- Ambos reemplazos fueron satisfactorios quedando la aeronave operativa.

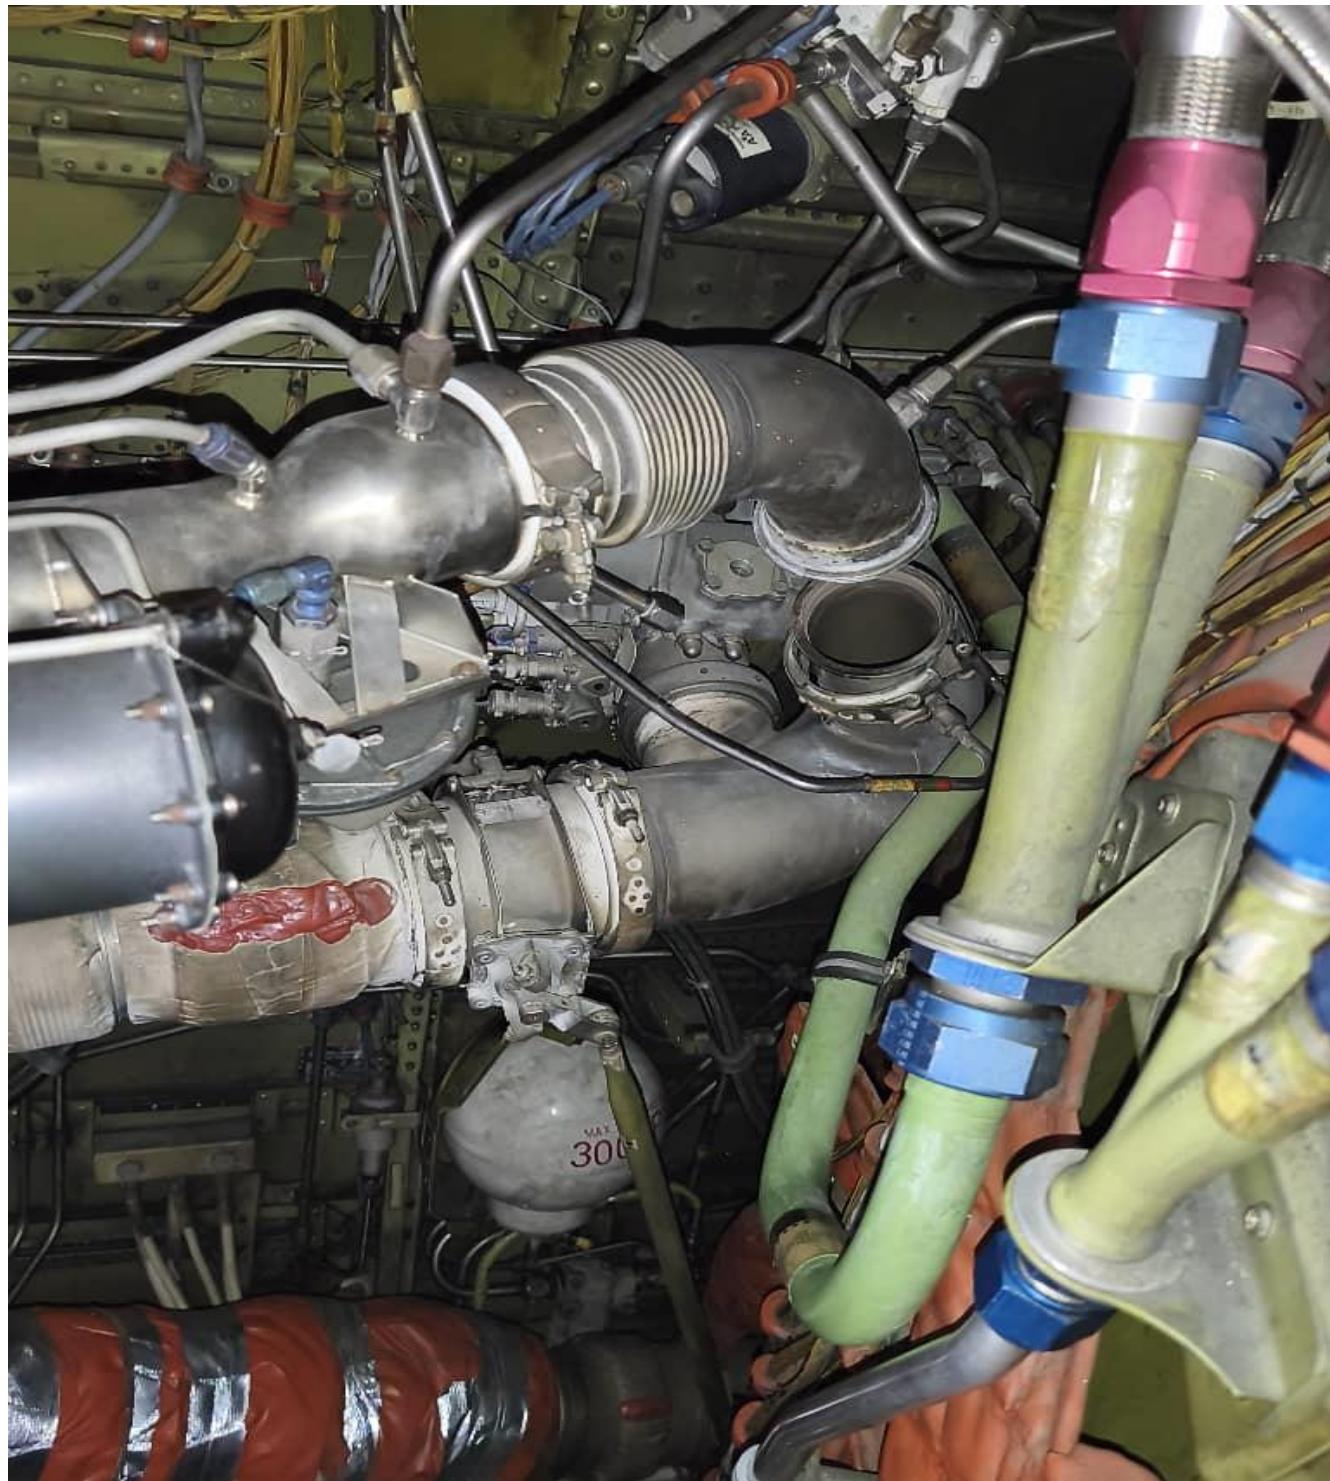
**Figura 5: Reemplazo de la Pressure Regulating Shutoff Valve YV3465.**

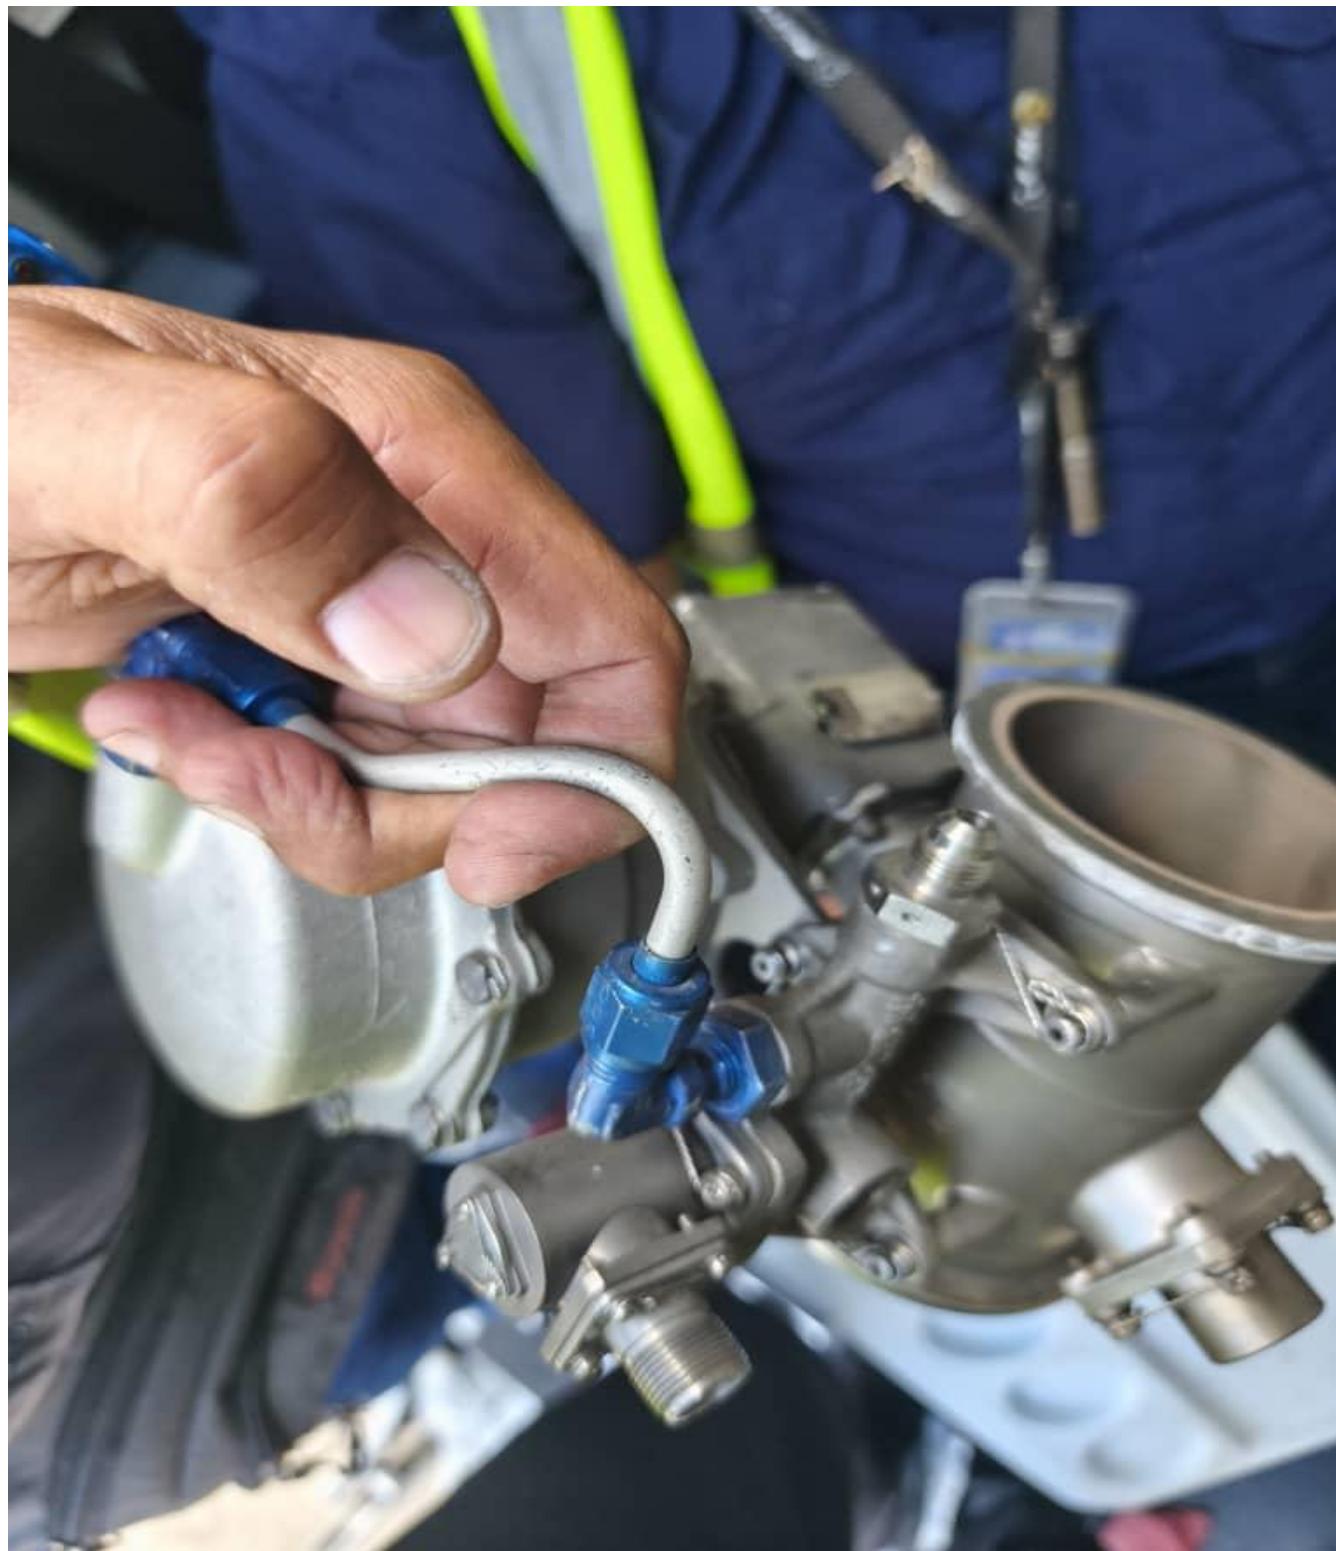
**Figura 6: Pressure Regulating Shutoff Valve YV3465.**  
**Fuente:** Investigador Encargado **Año:** 2025
